# COM3000 TROUBLESHOOTING MANUAL

COM400/COM421/COM51/COM50/QAM4

This document is intended as a job aid for troubleshooting Vantiva COM3000 systems. It is assumed that the reader has experience with COM systems and understands the operations of COM equipment.

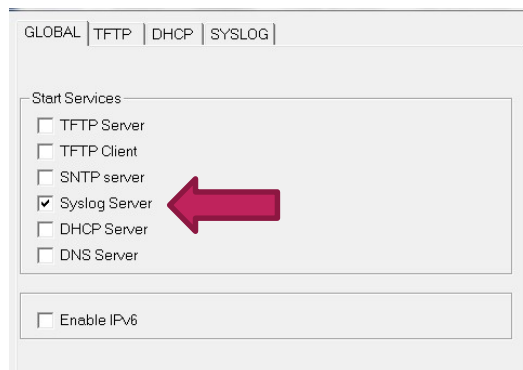
Open the Tftpd32 program and click on the GLOBAL settings. Select Syslog Server, uncheck other boxes. Click OK.

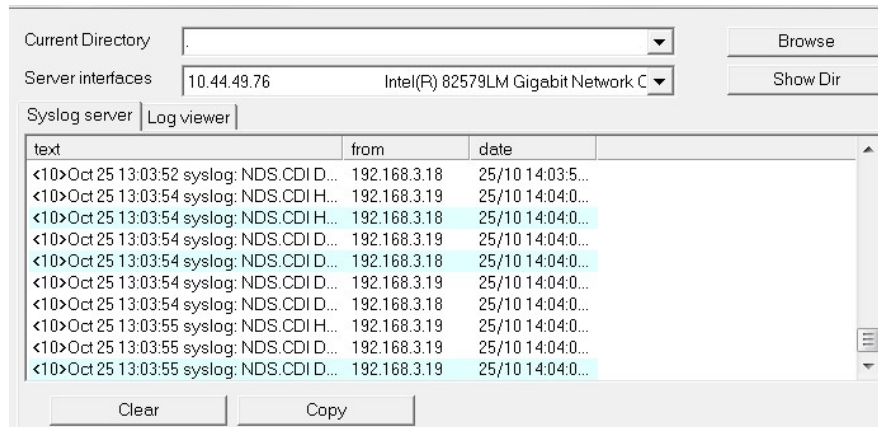
From the TFTP main screen select the “Syslog Server” tab. You will see the syslog information displayed in the text box, designated by the IP address of the card in the “from” column.
